## Drivelines and Axle Shafts

## Drivelines and Drive Shafts

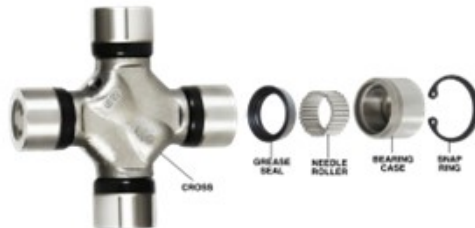
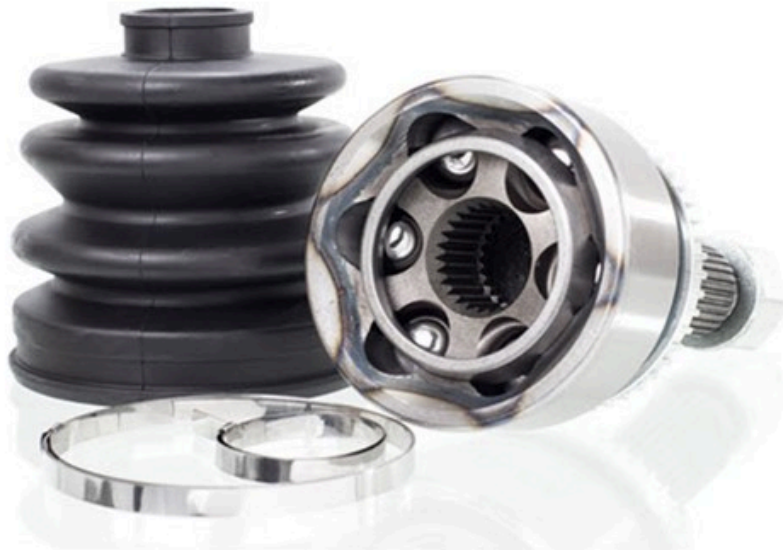
Figure 1

One way to identify and clarify the differences between what a driveline and a driveshaft is, is the type of flex joint used. The image on the left (above), is of a U-joint. U-joints are traditionally used on drivelines which are of a long hollow tube design. Drivelines are common to RWD light duty pick-ups and some SUV's. The image on the right is of CV or

constant velocity joint. These are found on driveshafts, which are short solid shafts that are common to FWD vehicles.

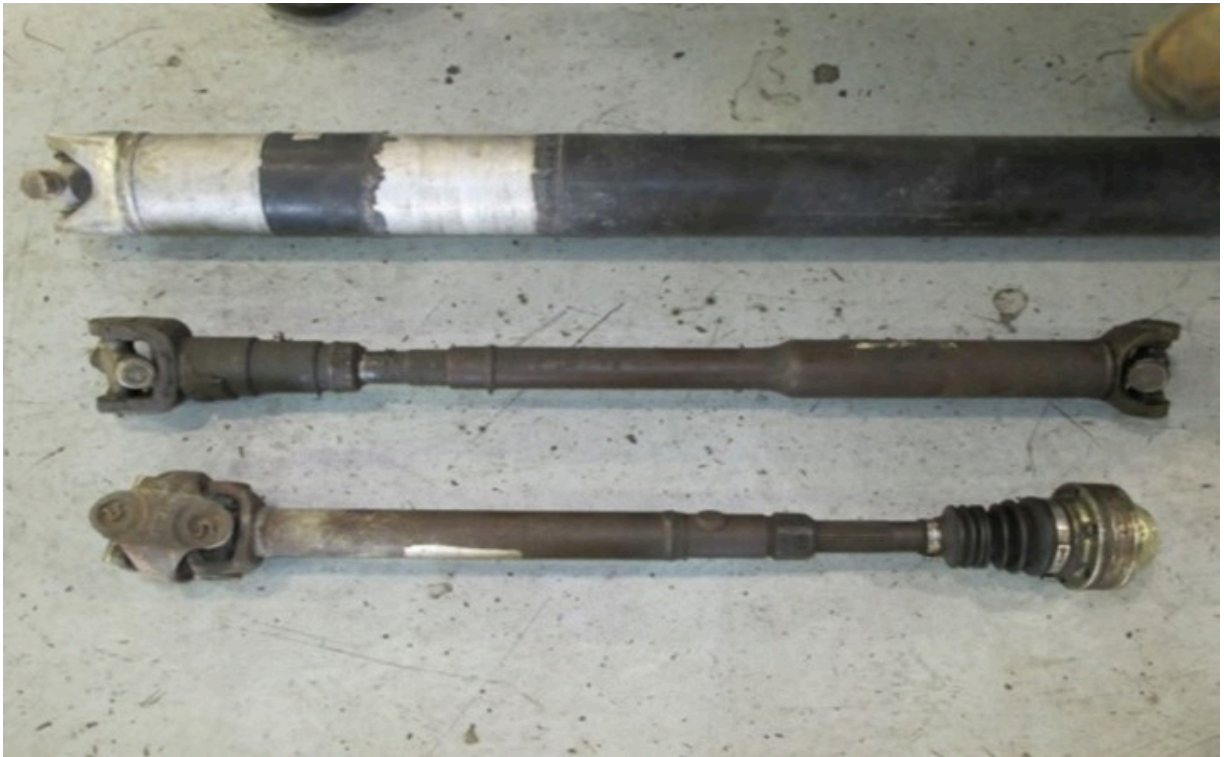
Figure 3

Here are three various drivelines. The *top* driveline is large in diameter and is made of aluminum. It's a *rear* driveline from a 2002 GMC pick-up truck.

The other two drivelines are *front* drivelines of what are often found on many full size 4WD (four-wheel drive), RWD (rear wheel drive) platform vehicles.

Note that the *middle* driveline has U-joints (universal joints) at each end while the *bottom* one has a double cardan joint (two back-to-back U-joints) on the left end and a CV joint on the right.

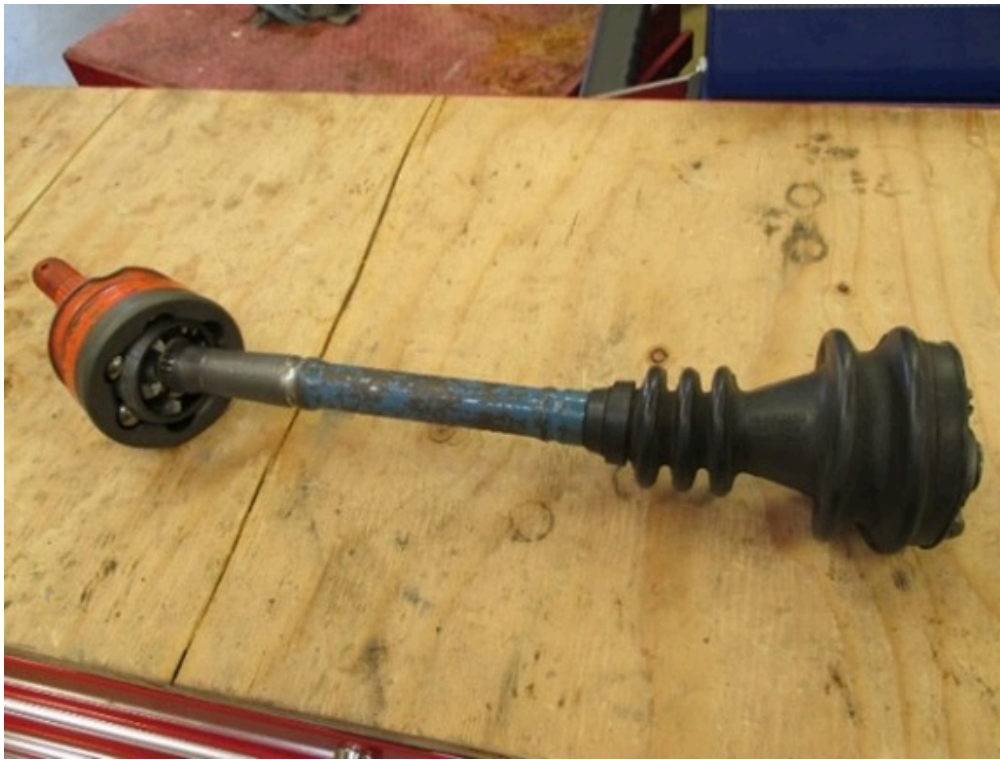
Figure 4 is of a half shaft or CV shaft. These shafts have been around for many years and are also found on outdoor recreational vehicles. As described earlier these drive shafts have a CV joint at each end.

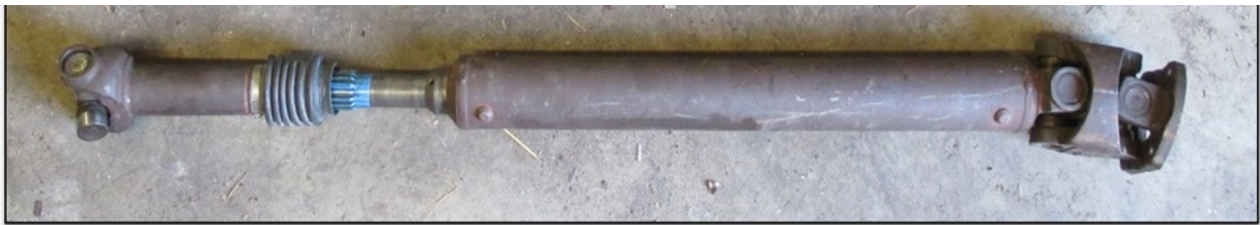
Figure 5

When it comes to servicing drivelines, as pictured below, the repair practices are different compared to CV shafts. With drivelines, U-joint replacement may be all that is needed and is the most common type of repair. If there are other issues with the driveline, like worn slip yoke splines then the driveline will need to be sent to a driveline shop that can replace the slip yoke. If ever the driveline becomes bent, the only option is driveline replacement.

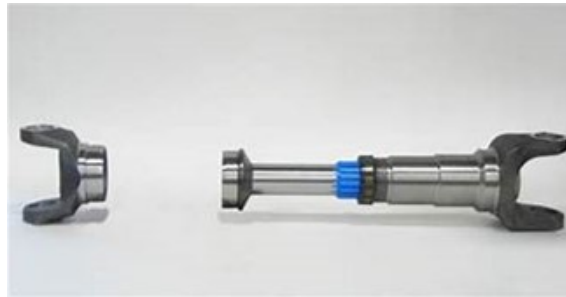
Figure 8

Another thing to point out is that there are two different drive yokes. First, the one circled below in **red** is an inner yoke and gets welded to the driveline itself during manufacturing, which makes it part of the driveline; therefore, this yoke will speed fluctuate along with the driveline as it rotates. The other drive yoke is the one that attaches to the transmission or to the differential. This outer yoke rotates in a steady or constant fashion.

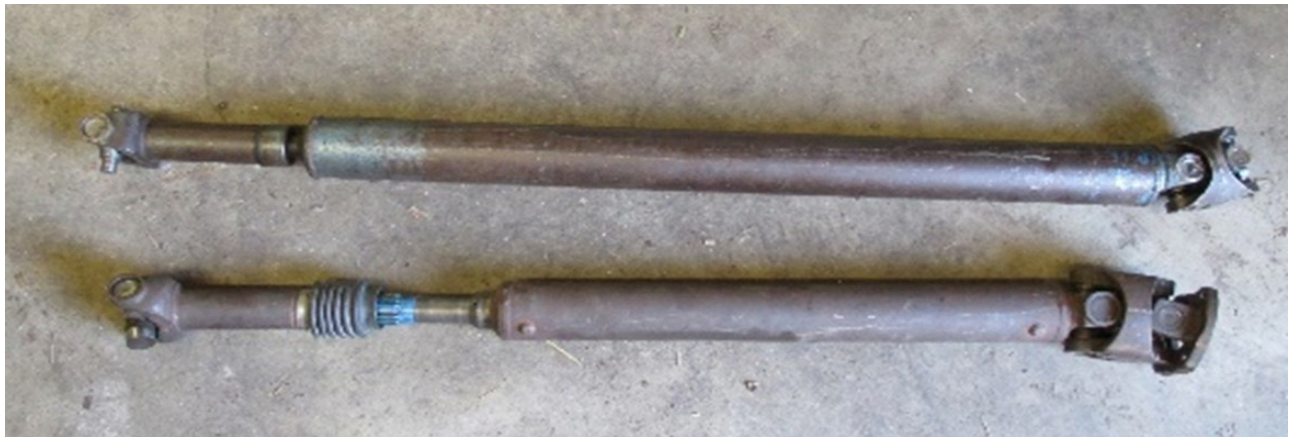
Figure 11 demonstrates what “**in phase**” means. The red line through the *top* driveline shows how the U-joints are lined up with each other. The *bottom* driveline U-joints are not in phase. In phase means the drive yokes at each end of the propeller shaft are on the same plane, which is to say they are *in line* with each other.

An out of phase U-joint condition is only possible on two-piece drivelines not one-piece unless the driveline has become twisted.

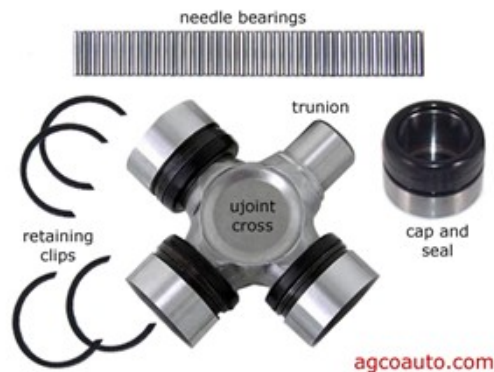
Figure 16 is an image of what a U-joint is comprised of. Universal joints more correctly called **Cardan joints**, are considered to be one of the oldest designs of flexible rotating couplings known to man. A Cardan joint consists of a one-piece cross that has four smooth machined **trunnion** areas. These trunnions support several precisely manufactured **needle bearings** that in turn support four **caps**. The bearings require grease in order to give long service life. Most U-joints on today's vehicles are sealed meaning they cannot be greased, but when a U-joint gets replaced with an aftermarket part, quite often a grease Zerk is provided so that the joint can be lubricated.

Additionally, the caps must be retained in place with **retaining clips** in order to keep the joint from flying apart as it rotates at significant speeds.

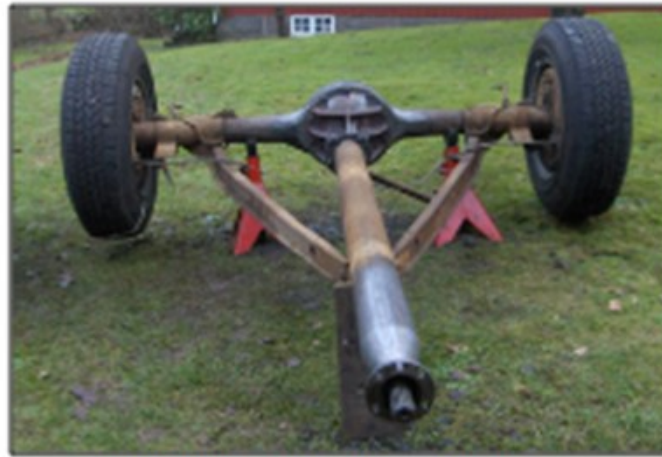
Figure 19

Note the angular beams – figure 19 – that extend from the torque tube back to the differential housing. These give added support to prevent differential wind-up. The objective of this system is to send all of an engine’s available torque directly to the drive wheels.

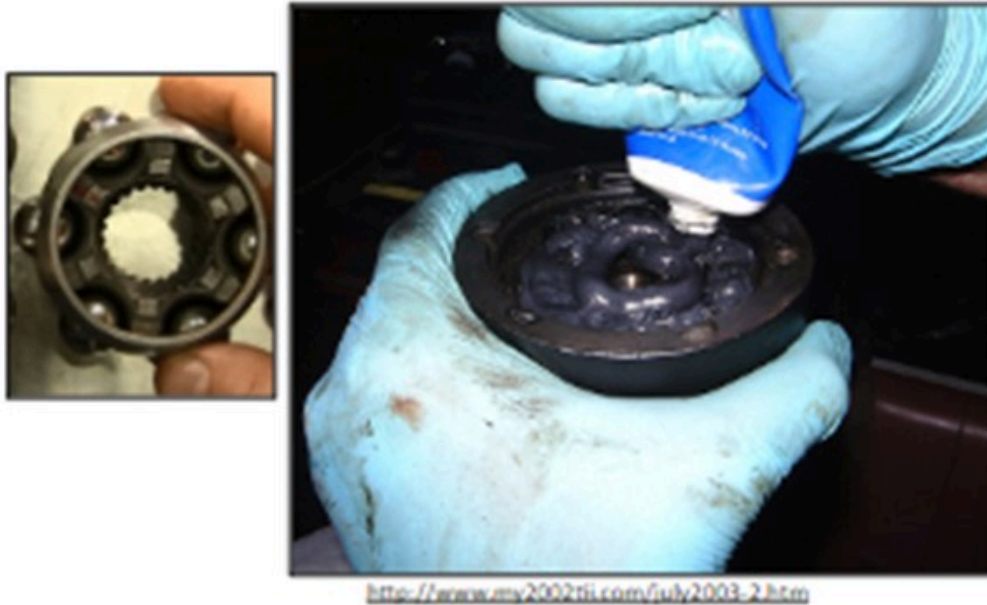
Figure 21

If a clicking noise is heard while maneuvering through a turn to **the right**, the problem or worn joint is the left CV joint. The principle is: if a joint is worn, then the joint where most of vehicle's weight is imposed will make noise. When this occurs, half shaft replacement is recommended. The point here is there is no immediate problem, and such noise can exist for some time.

Lastly, the clicking noise results when enough wear has occurred between the steel balls and the grooves that they travel across inside the joint.

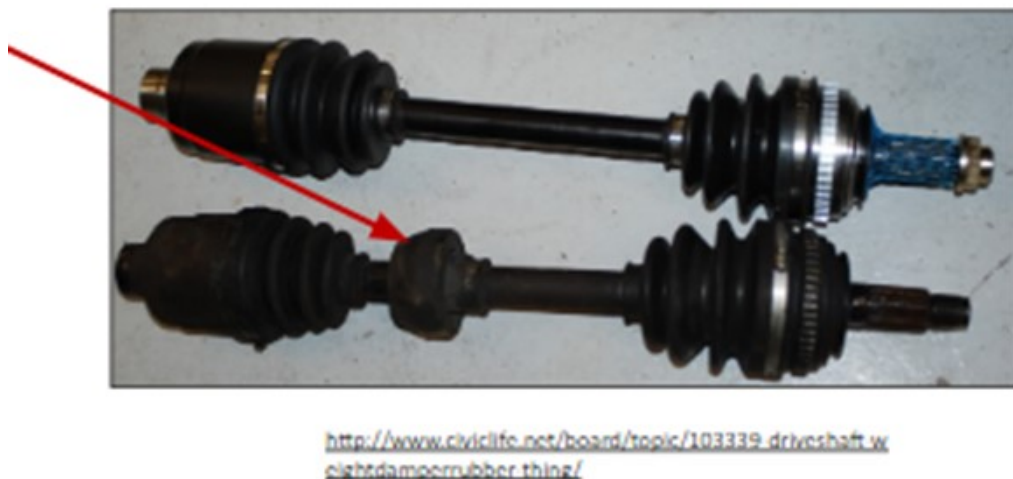
Figure 24

3. Something else seen with compact cars on one of the CV axle shafts is to use a **vibration damper**. This is simply a round rubber piece that gets attached around the shaft to absorb some shaft vibrations. The arrow in figure 24 points to a vibration dampener. Vehicles come from the factory with a damper, but quite often replacement shafts from an aftermarket part distributor do not come with one. Apparently, a damper's importance isn't great enough to include them on replacement shafts.

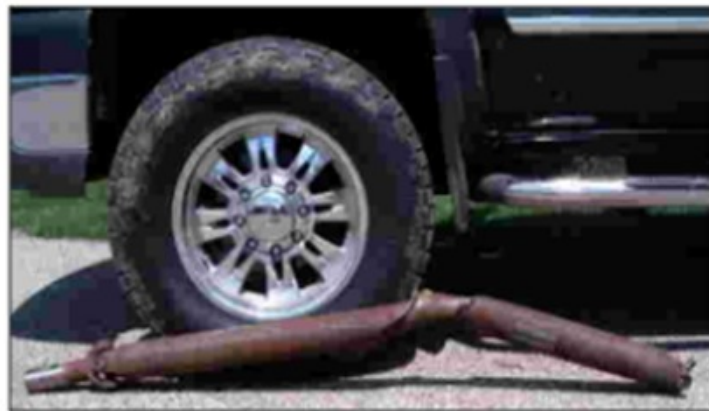
Figure 26 shows an example of what too much torque can do to a driveline.

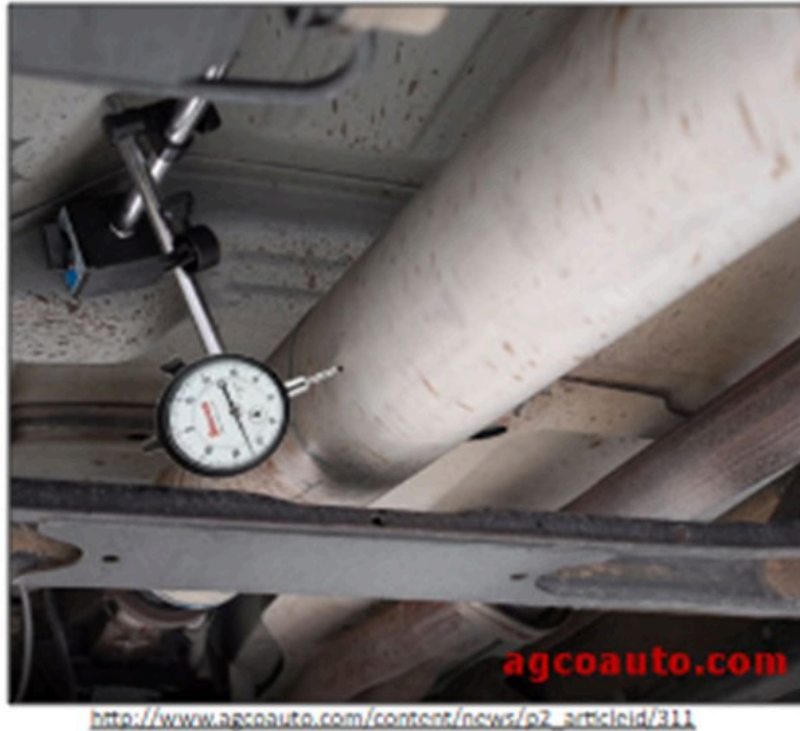
Figure 27

To measure to see if a driveline is **bent** use a dial indicator to measure in at least two different places. **1.** At the very center of the driveline, approximately **.040" (1 mm)** is the max allowed (see figure 27). **2.** The second place to measure is at either of the two ends of the driveline about six inches from where a welded yoke exists. Maximum run-out specification for this is **.015."**

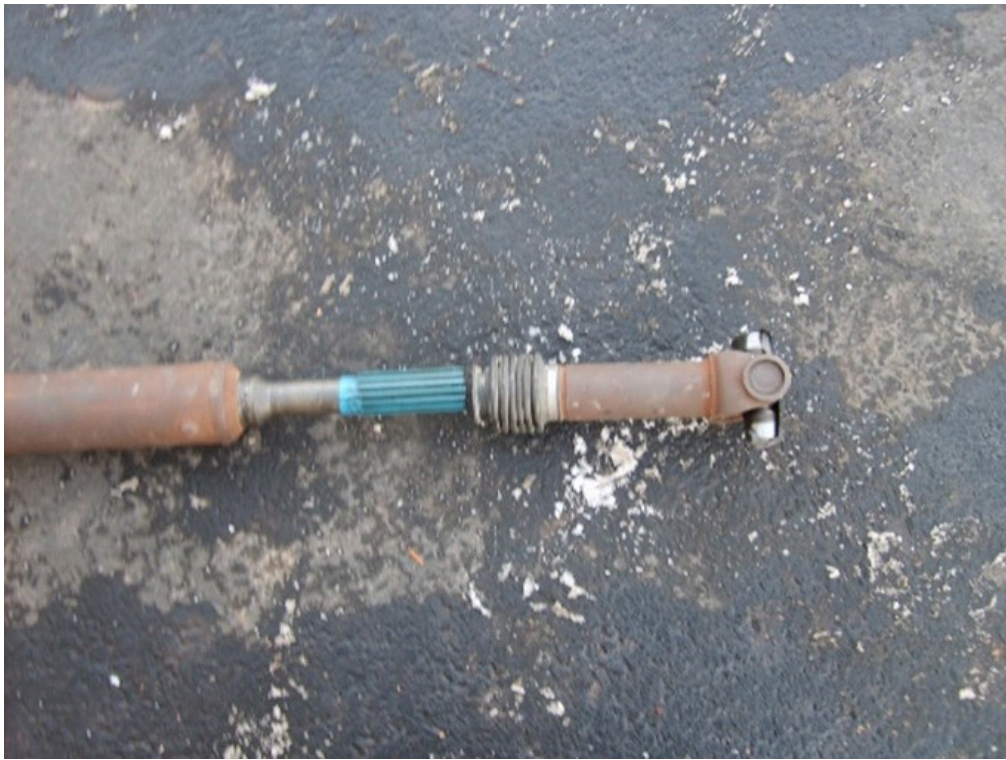
**Figure 29**

Here is one last insight about drive line **noises & vibrations**. Driveshaft **splines** (the blue colored teeth in figures 28 and 29) can become dry of lubricant or can be worn excessively. Worn spline teeth are inspected for looseness much like U-joints:

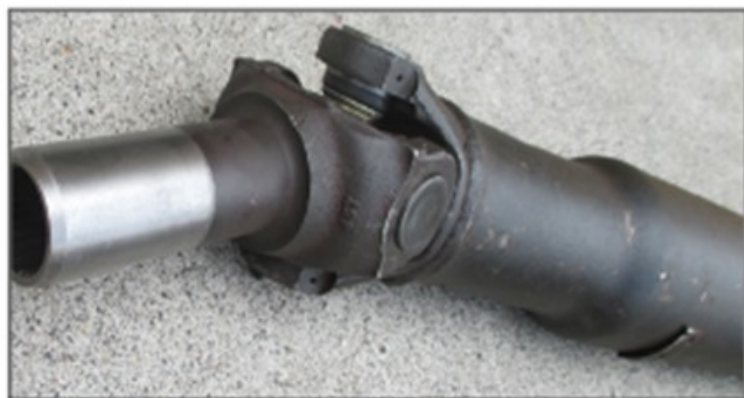
**Figure 31**

**Drive line balance weight**

Figure 28 shows a **balance weight** that the manufacturer welded in place. Out of balance driveline can be the cause of a vibration issue. Only a driveline shop can check driveline balance, but you can at least check to see or look for evidence for the possibility that a balance weight has come off.
